# Study on shelter response of Caritas Bangladesh for the Forcibly-Displaced Citizens of Myanmar

April-June 2018

September 2018

*Report prepared by CRAterre in collaboration with Caritas Bangladesh, Catholic Relief Services (CRS) and Bangladesh University of Engineering and Technology (BUET)*

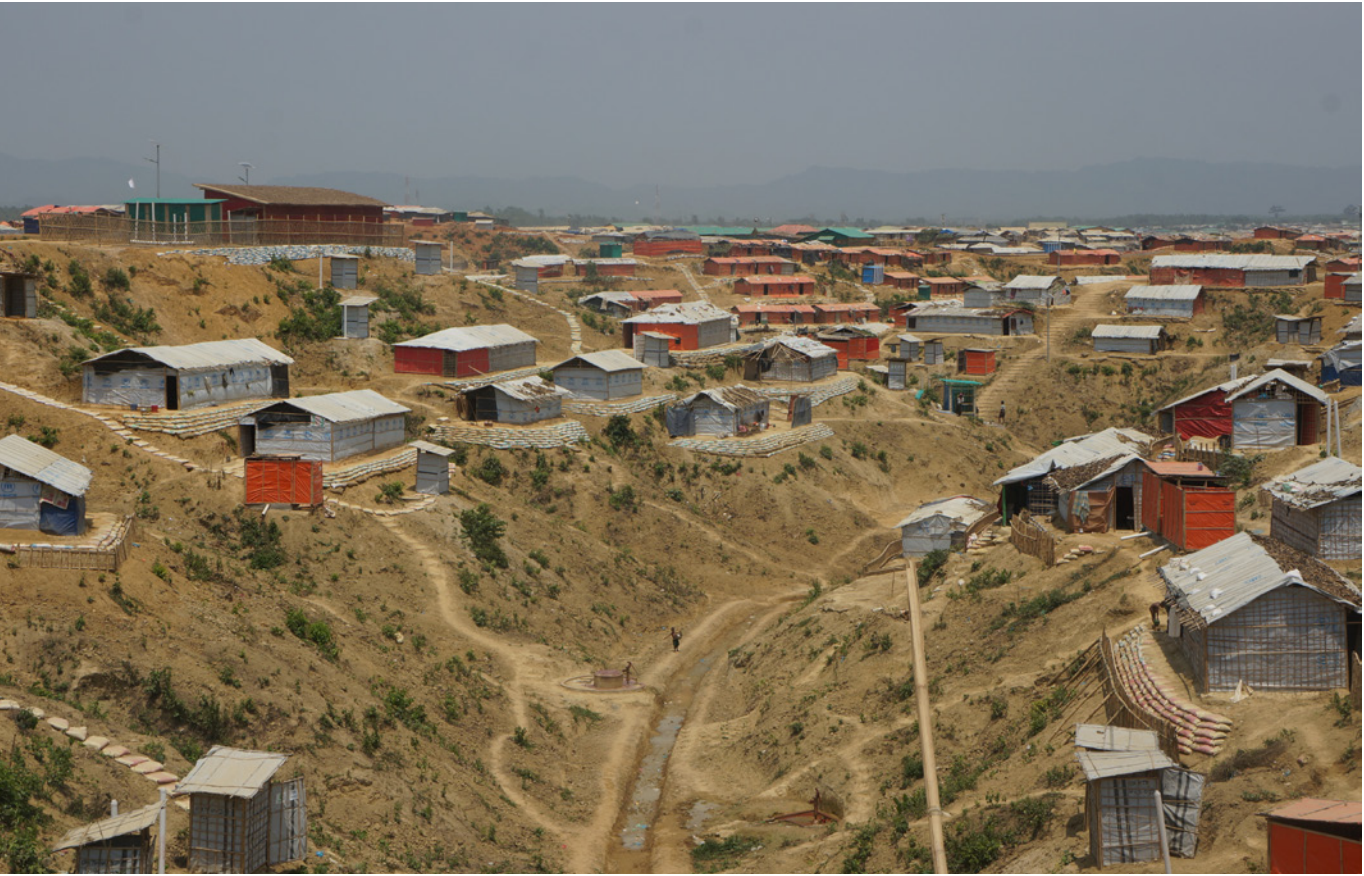
Top to bottom :  
 General view of PP zone, Kutupalong  
 Stairs and drainage, BB zone, Kutupalong  
 Stairway made out of cement bags filled with mud, PP zone,  
 Kutupalong

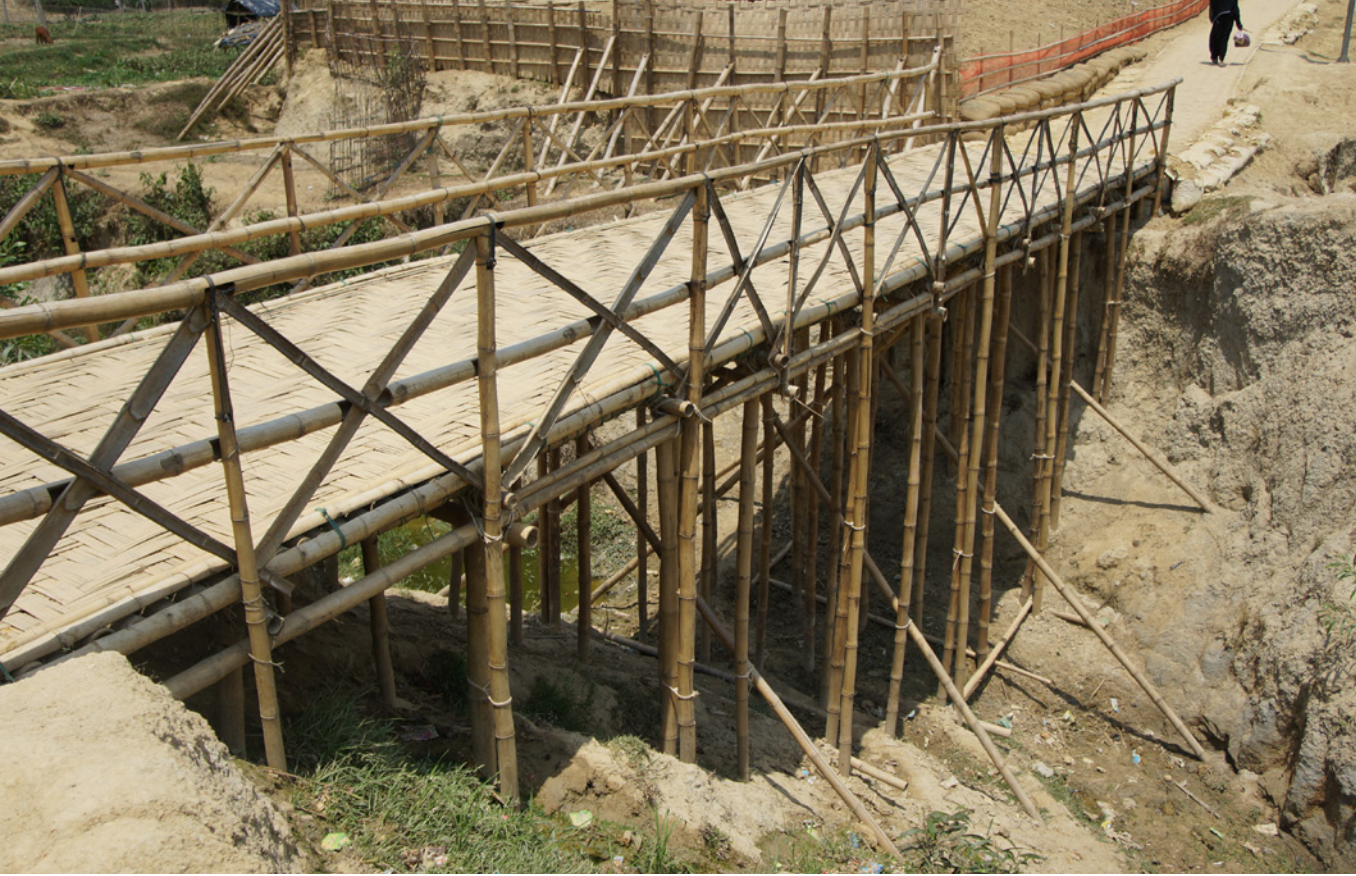
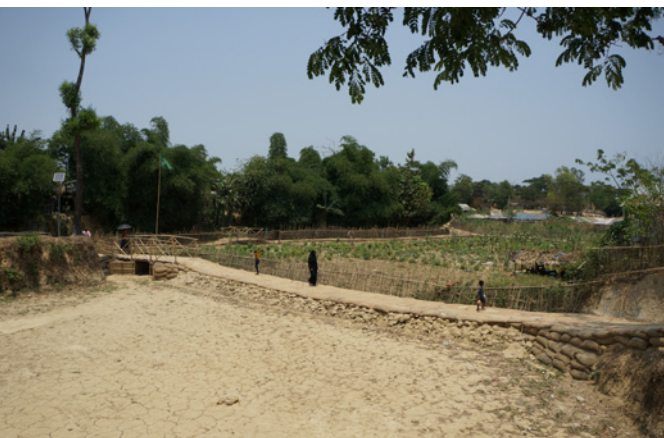
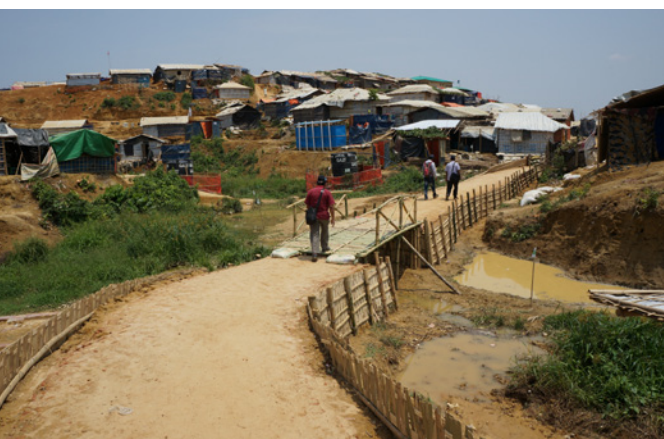
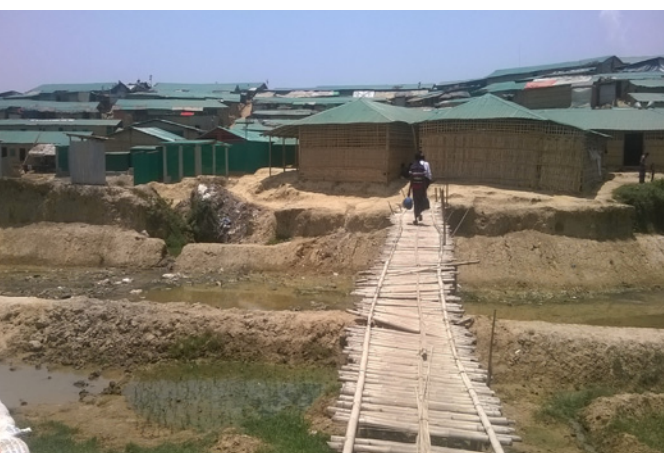
- Safe bridges present safe structure including safe bridge deck and guard rail.
  - But some bridges are not maintained, have very high post, no guard rail. These bridges have a short lifespan, the bamboo structure and deck are very exposed to the elements (no protection from sun and rain) and decaying agents (posts buried in the ground, then dipping in the rivers, no treatment).

*Raised path and bamboo bridge, Nayapara new camp,  
 Bamboo bridge Nayapara new camp  
 Raised path and bridge, PP zone, Kutupalong  
 Unsafe bamboo bridge, Camp 3, Kutupalong*

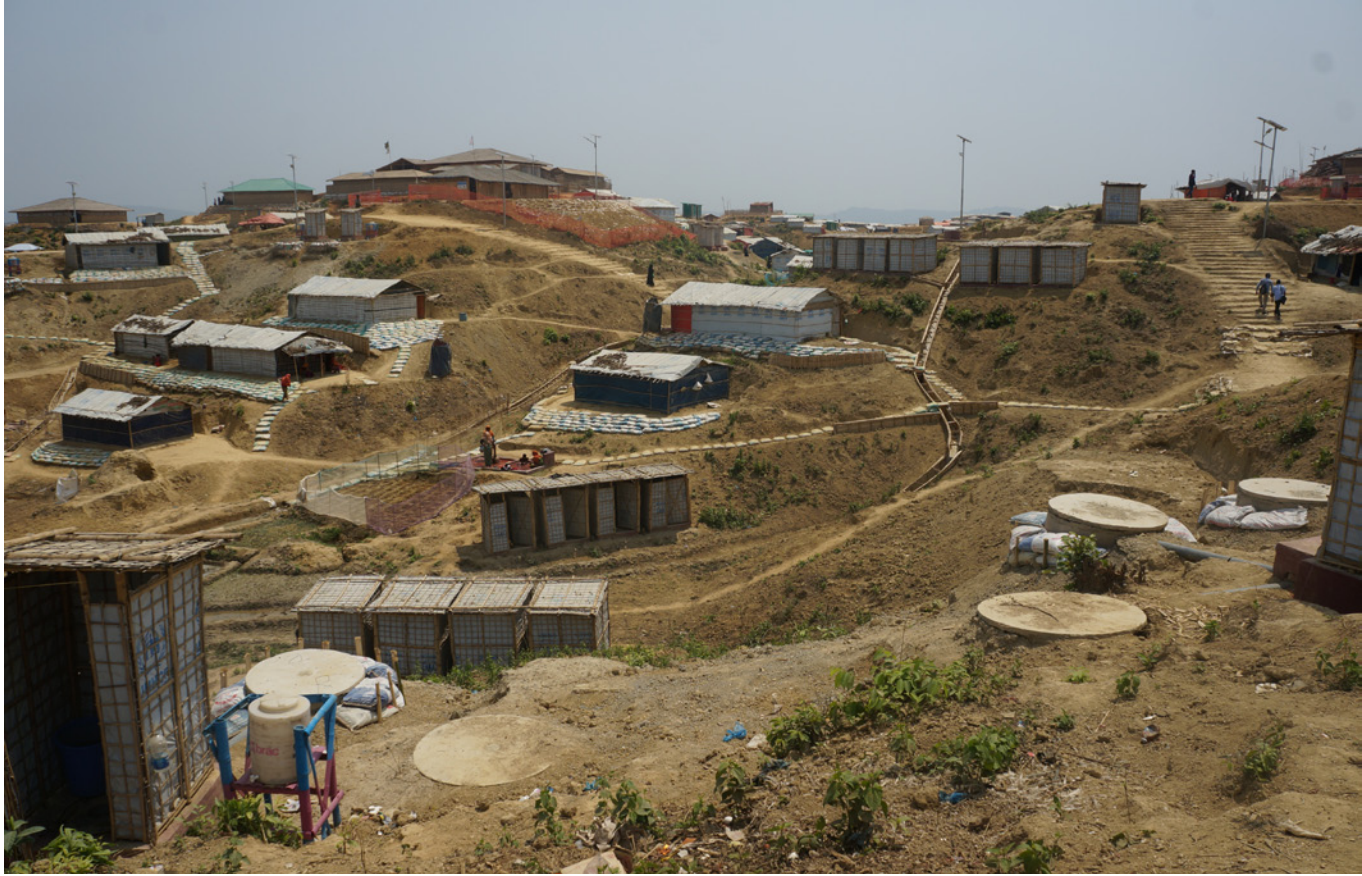
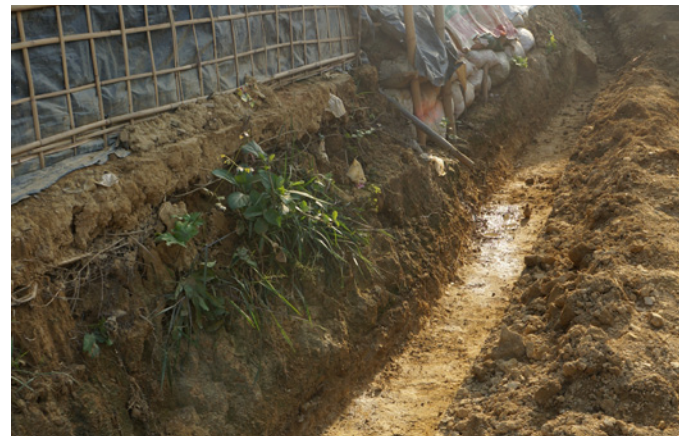
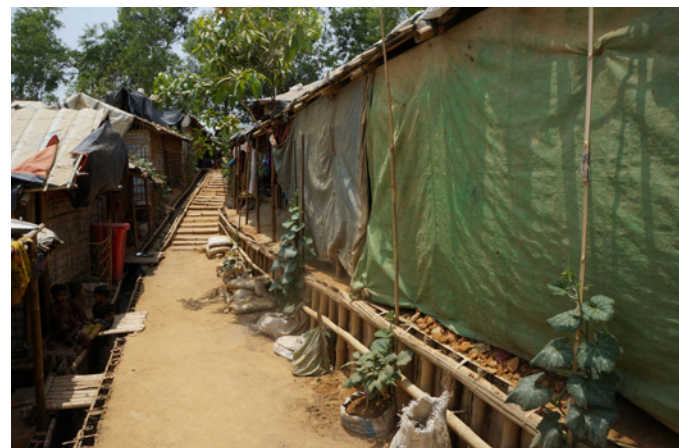
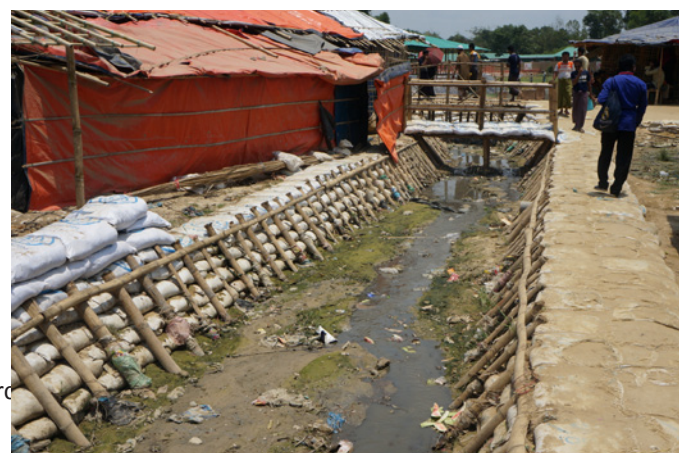
There is a high need for maintenance of the drainage system, if not the risk of flooding is increased (for instance, torn polythene pieces may cause many problems). No maintenance committee organized so far.

top :  
 UU zone, general view  
 Right:  
 3 types of drainage:  
 Shelter level  
 Path level, BB zone Kutapalong camp 1  
 Riverbed level, Balukhali Kutupalong camp 9

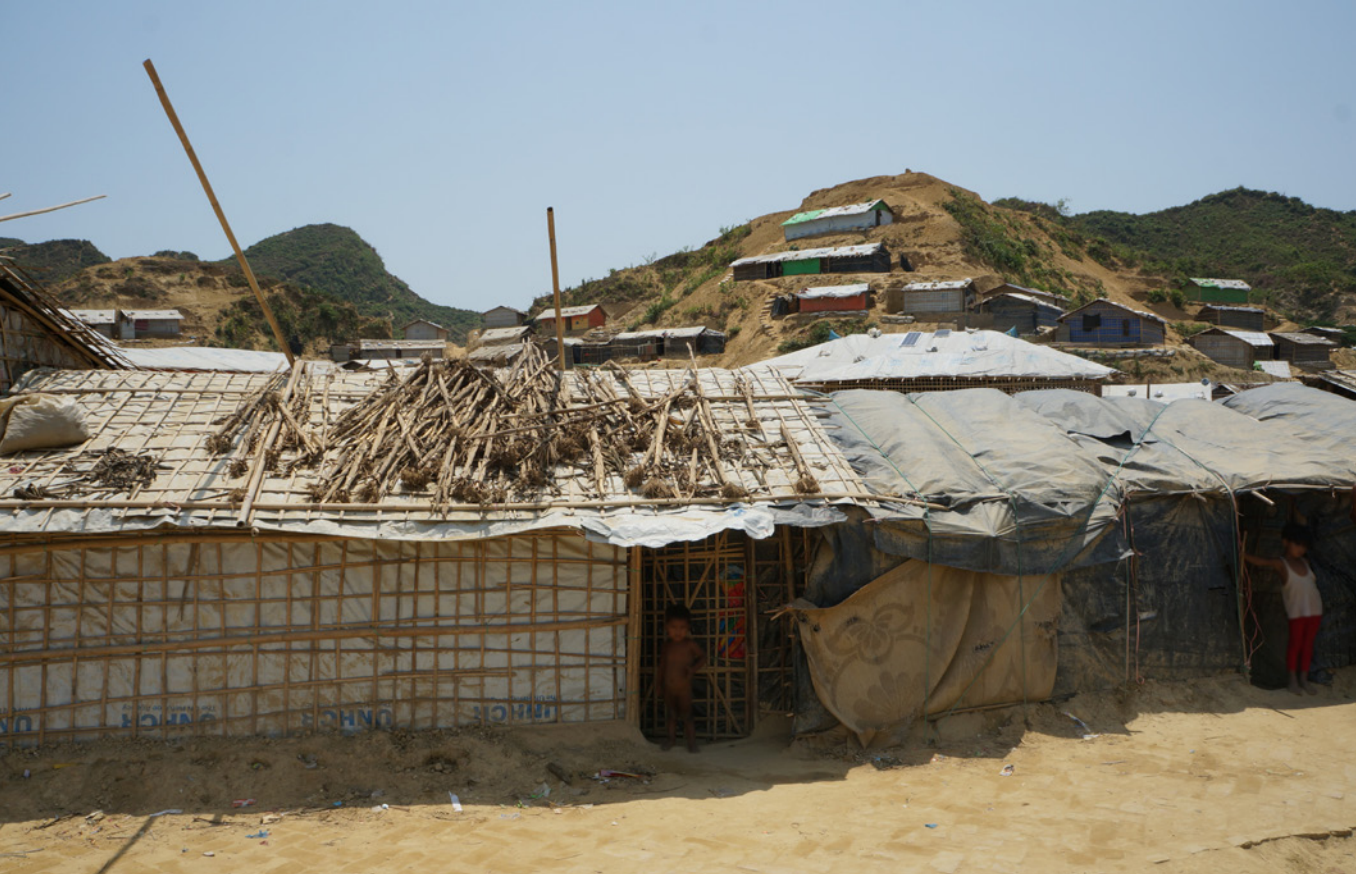
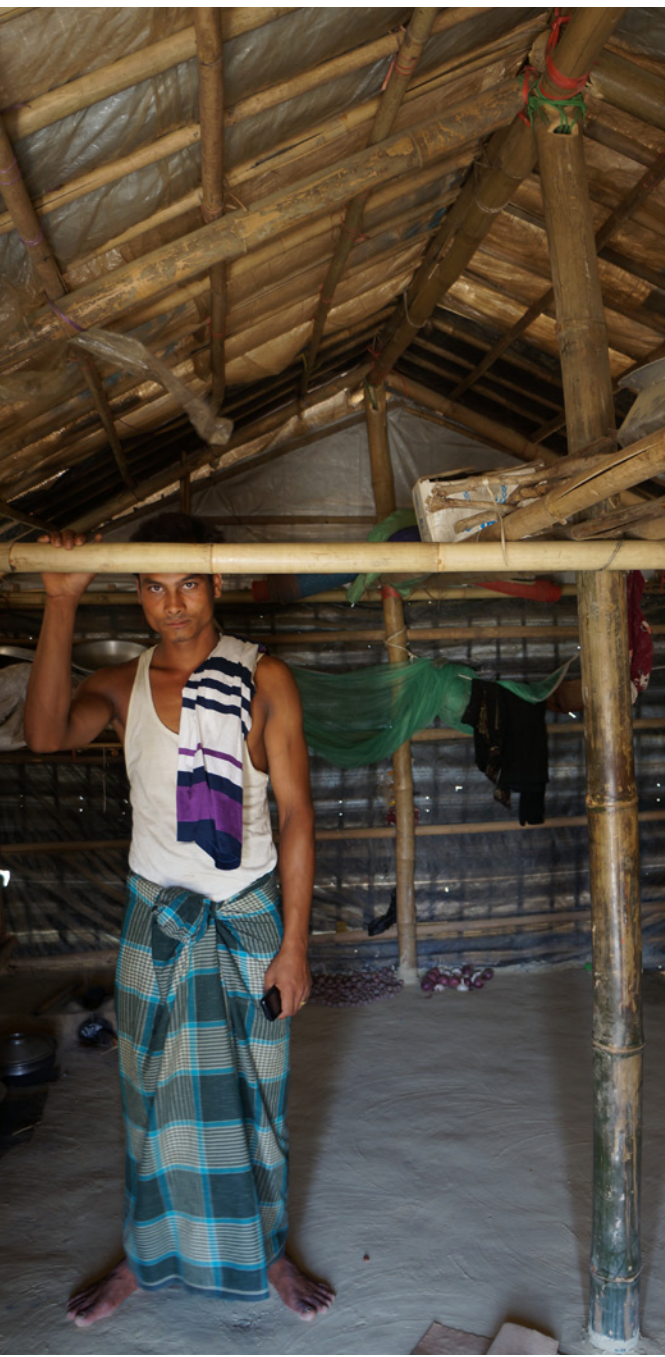
top :  
Emergency shelter (right) & Upgraded shelter (left), Naya-  
para new camp  
bottom:  
Inside Emergency shelter, low structure

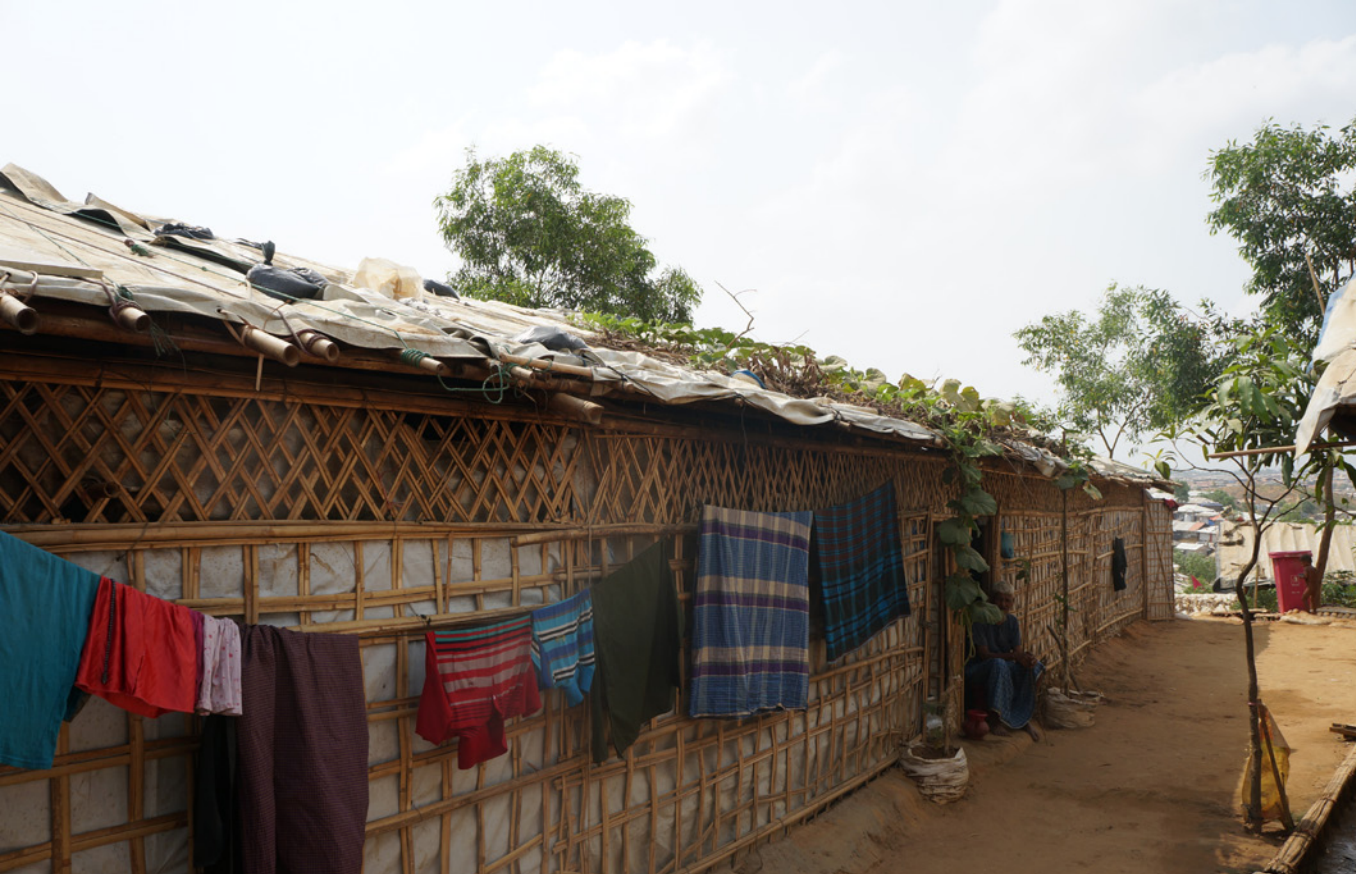
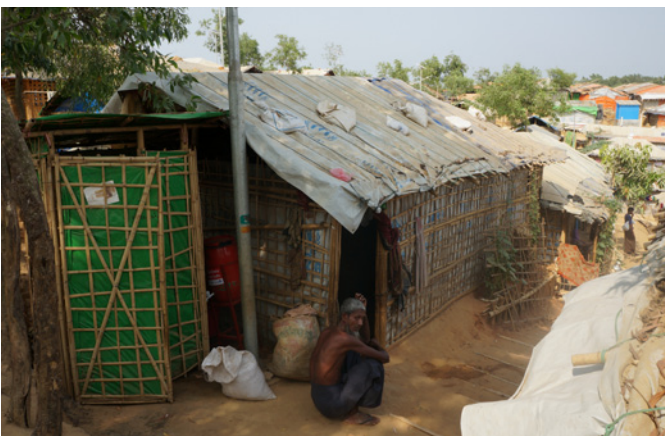
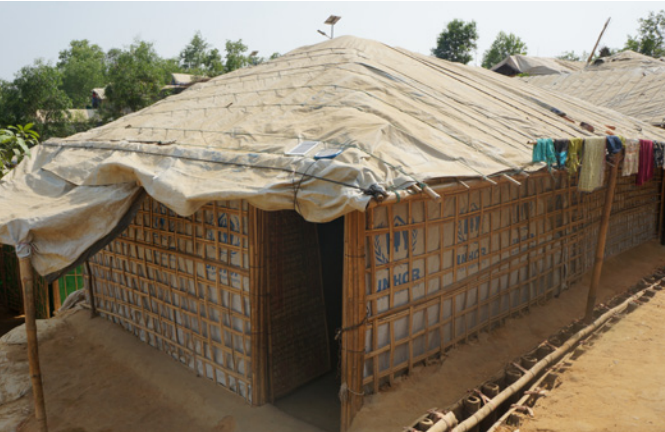
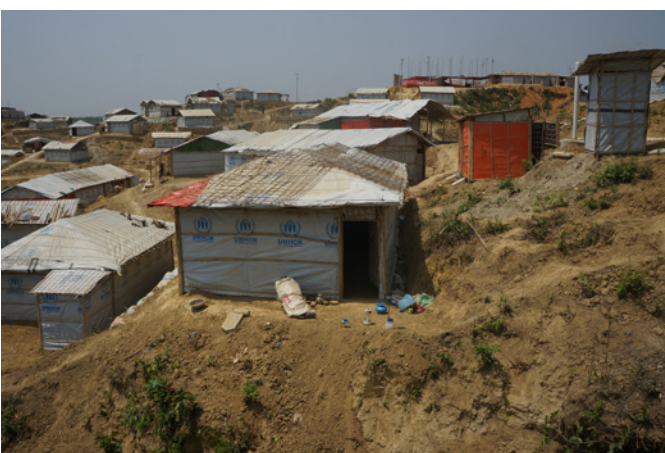
*Top:  
Upgraded shelter cluster, BB zone Kutupalong*

*Bottom:  
2 pitched roof Upgarded shelter, BBzone Kutupalong  
4 pitched roof Upgraded shelter, BB Kutupalong  
External bath and latrines, PP zone Kutupalong*

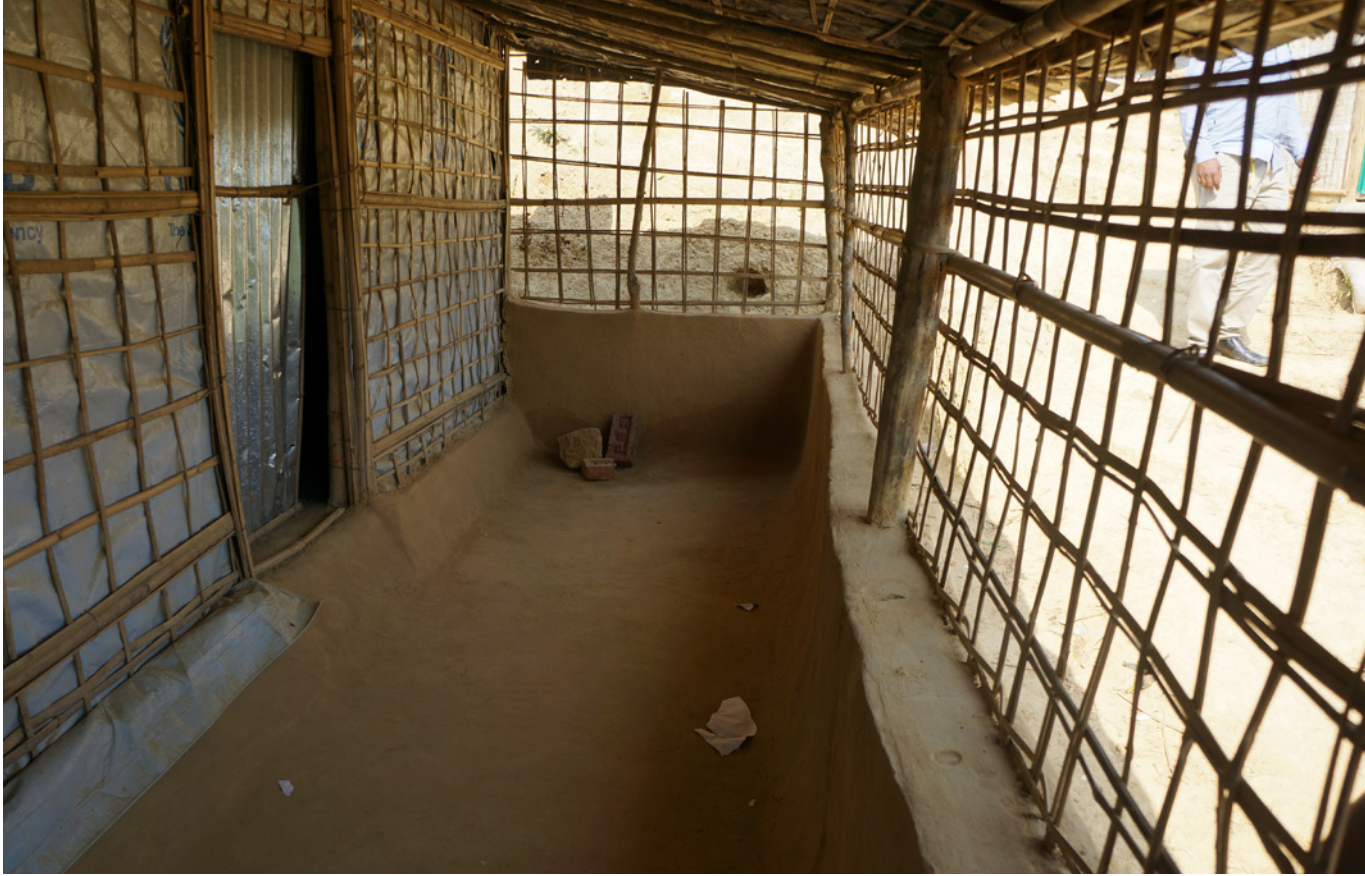
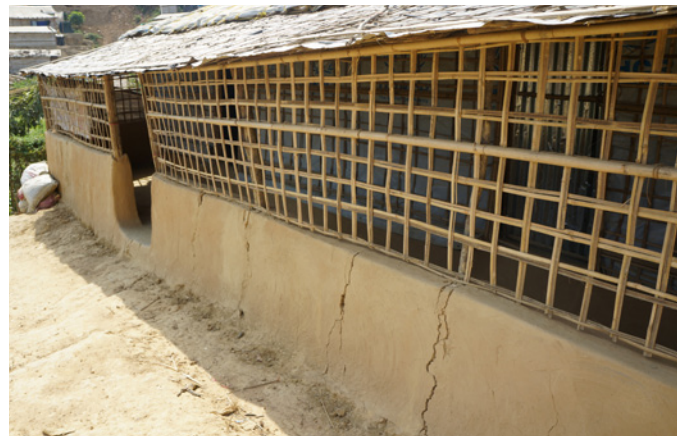
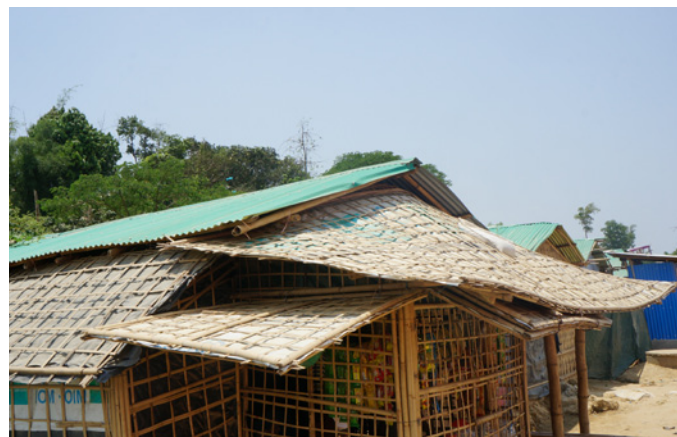
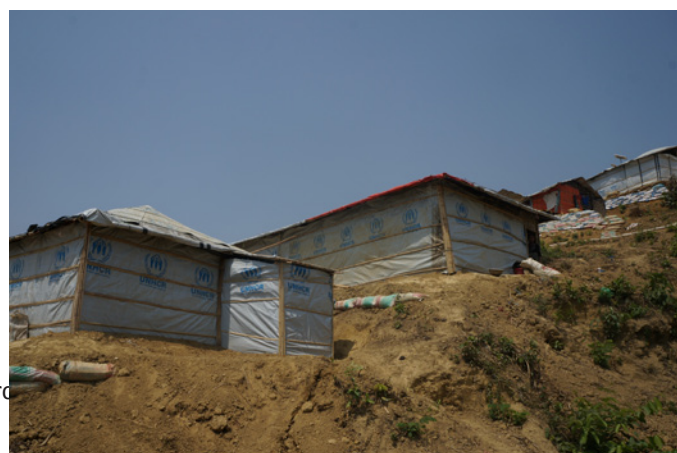
Top:  
extension of upgraded shelter, veranda, PP zone Kutupalong  
Bottom:  
Extension of Upgraded shelter, with bamboo +tarpaulin, PP  
zone Kutupalong  
*extension of upgraded shelter, Balukhali camp 9 Kutupalong*

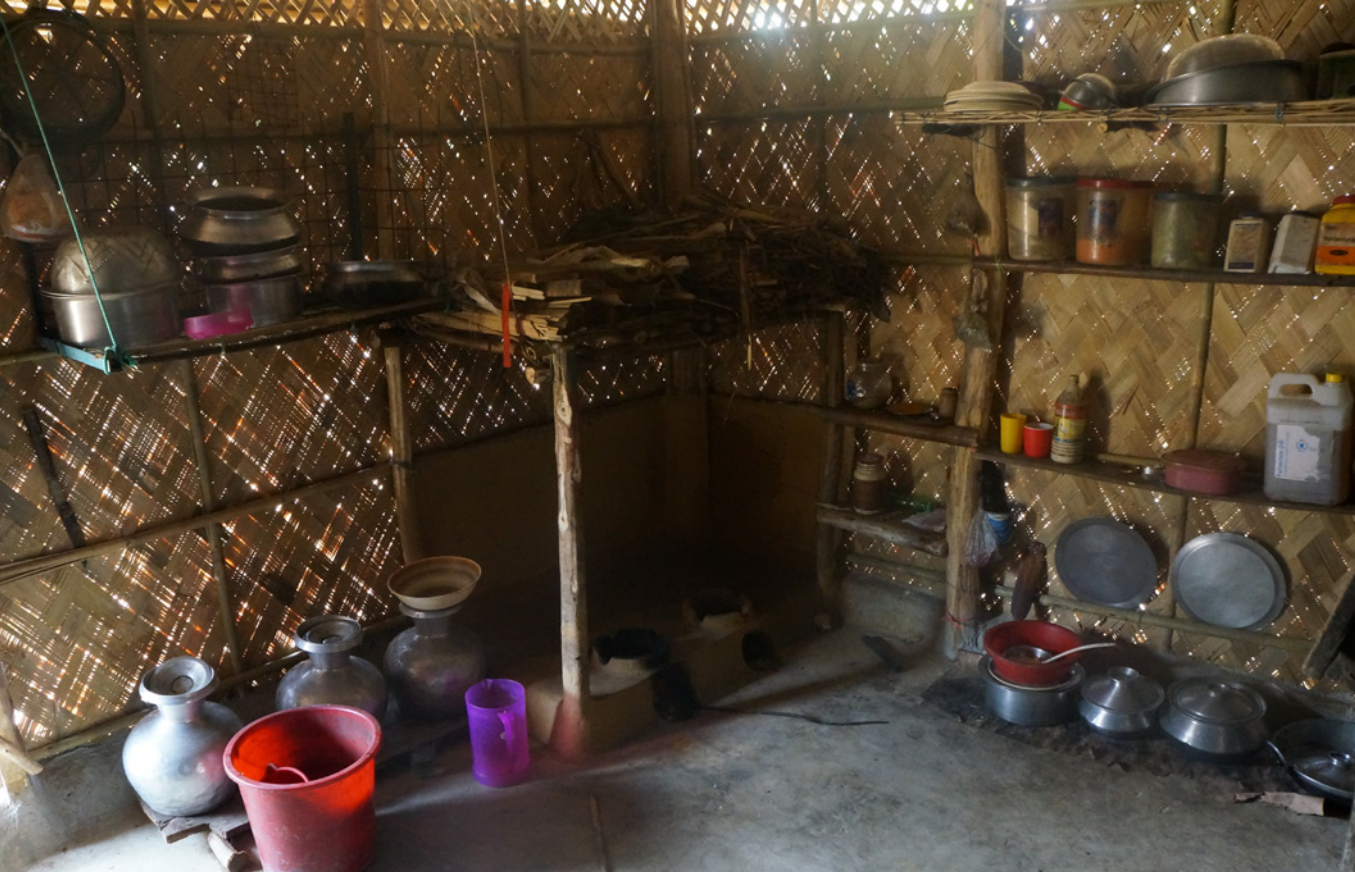
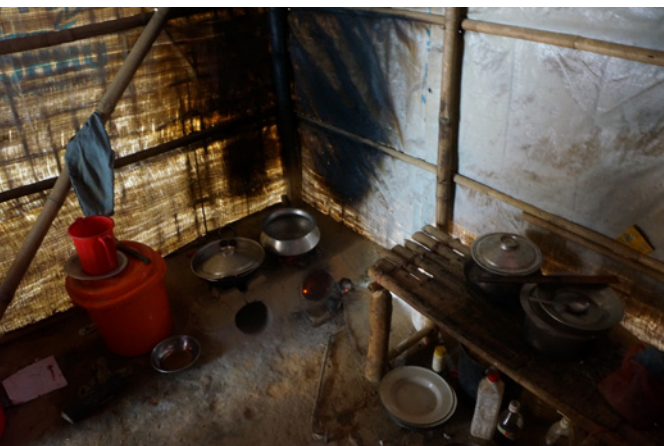
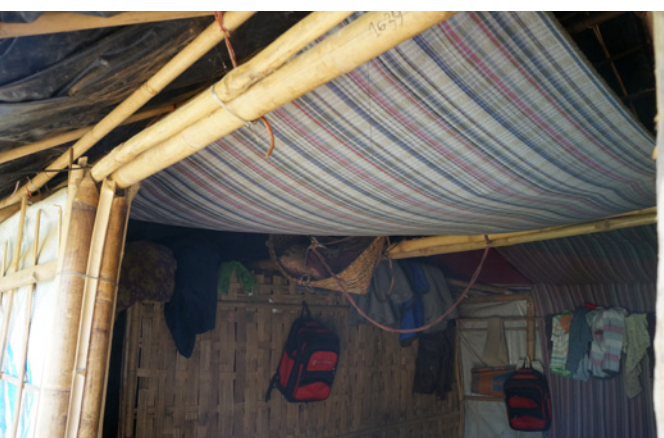
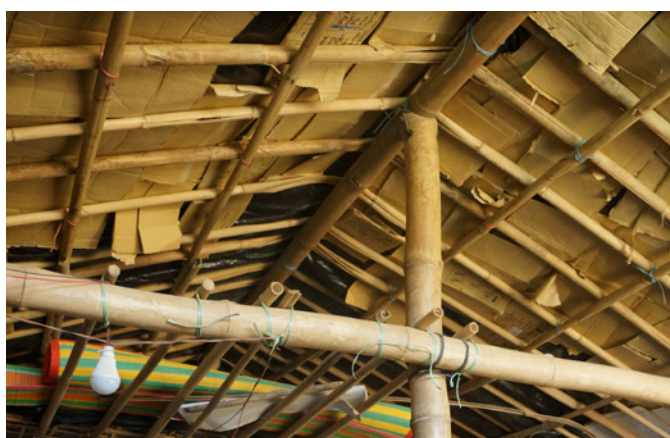
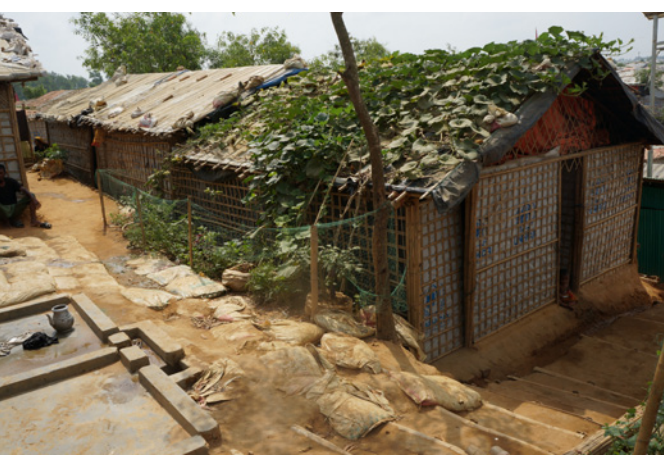
Top:  
cooking space, mud plaster protection of fence, BB zone Kutupalong  
Bottom  
cooking space, fire risk on fence, BB zone Kutupalong  
Mud platform  
Clothes ceiling / Cardboard ceiling, PP zone Kutupalong  
Growing vegetation on tarpaulin roof (risk of fast decay), BB zone Kutupalong

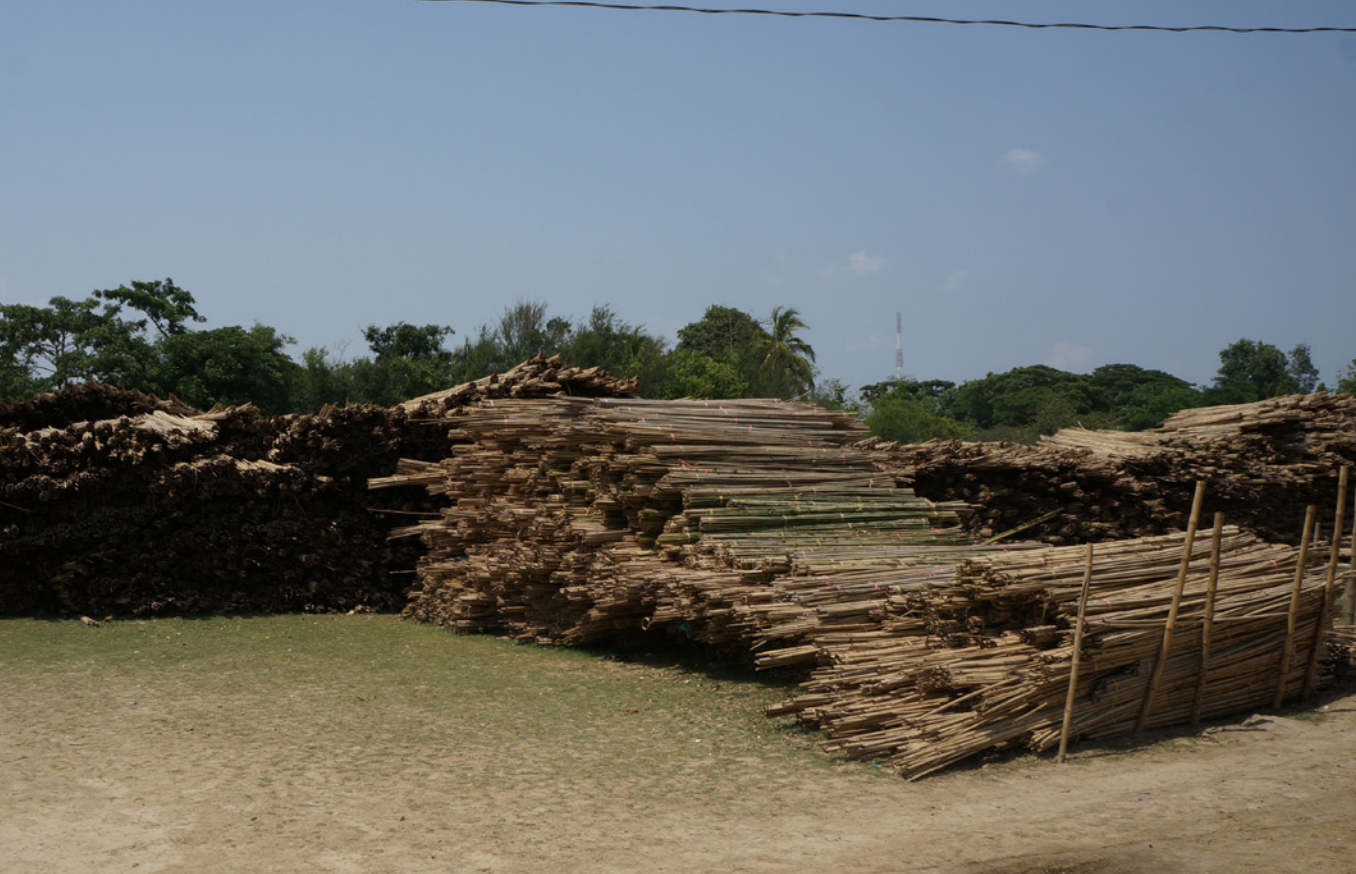
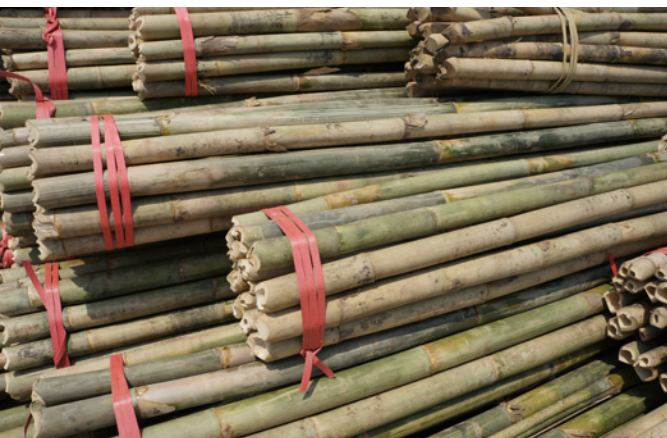
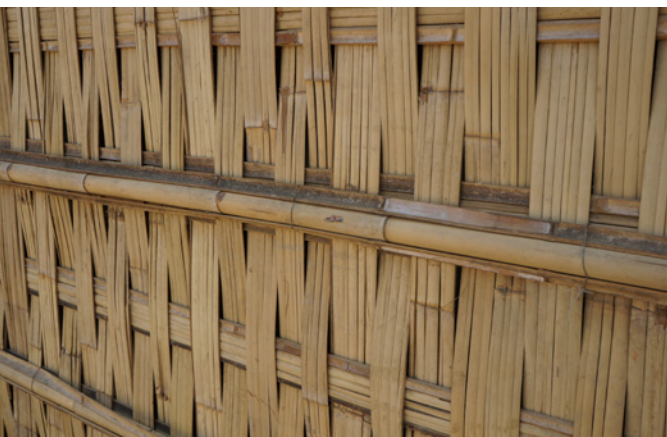
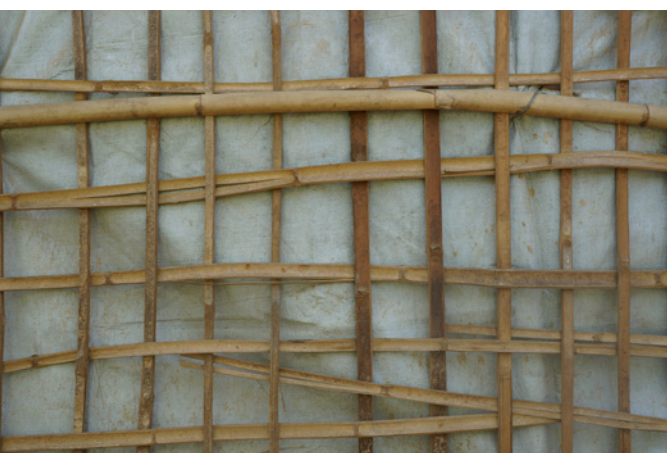
Bamboo is not treated nor seasoned, as the demand is acute and the season for cutting bamboo is ending, quality of bamboo is decreasing (immature bamboo is procured). First termites' attacks can be observed after 2 months.

*Bamboo decay due to running water*

*Bamboo cracking due to hammering*

*Bamboo stored directly on the ground, no rain nor sun protection.*

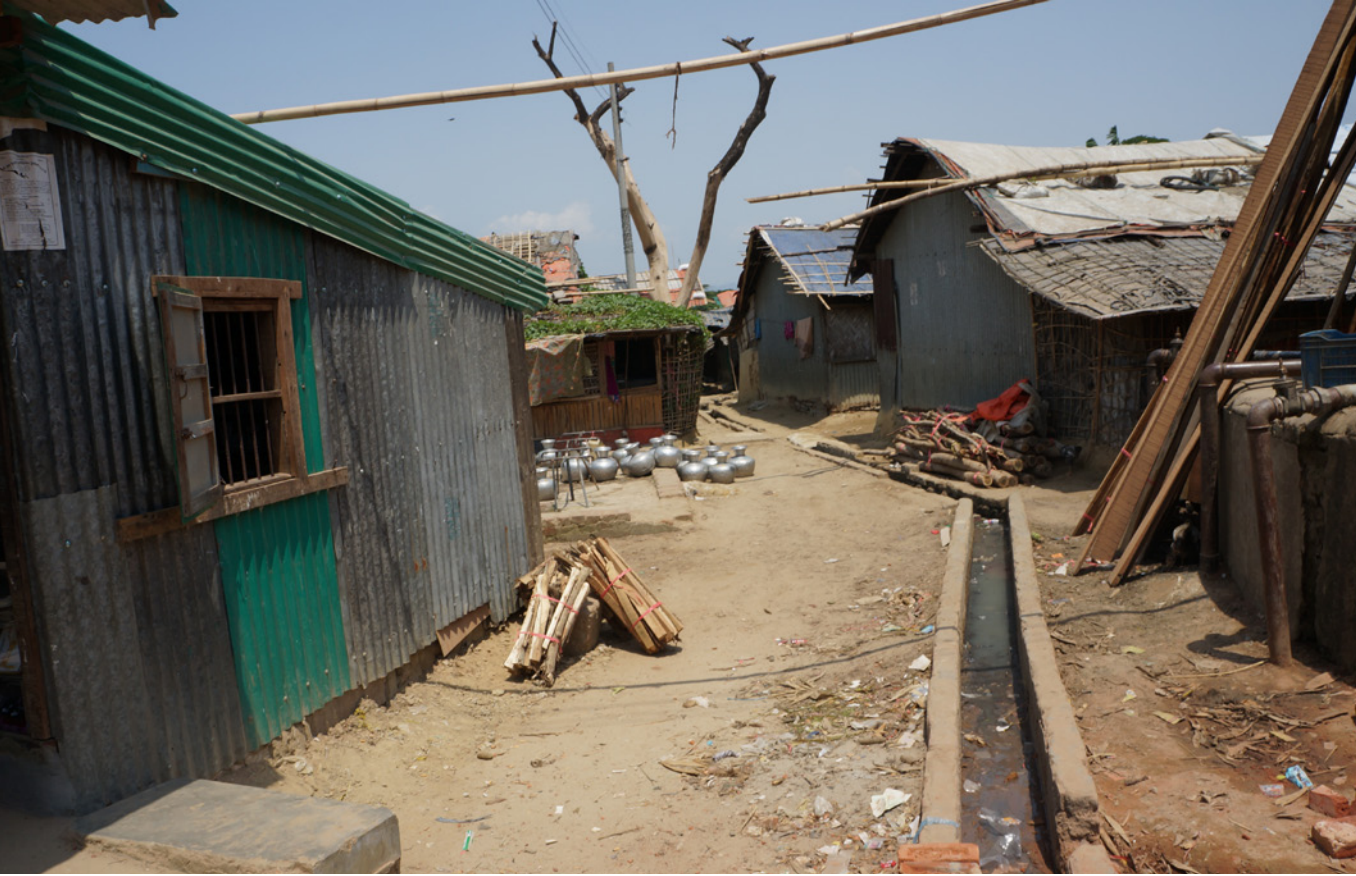
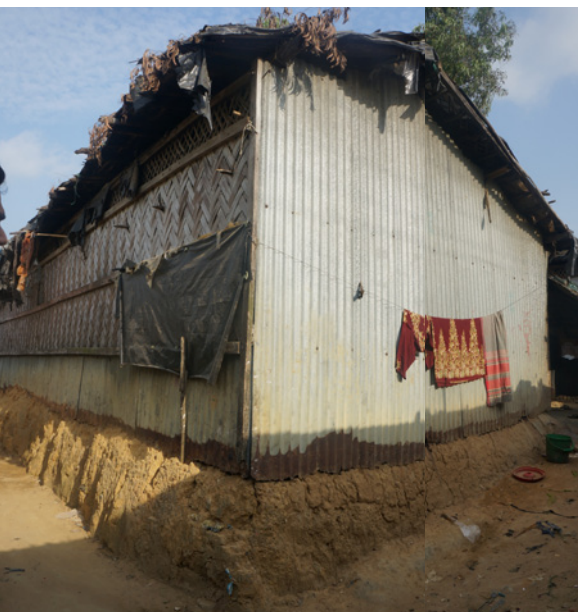
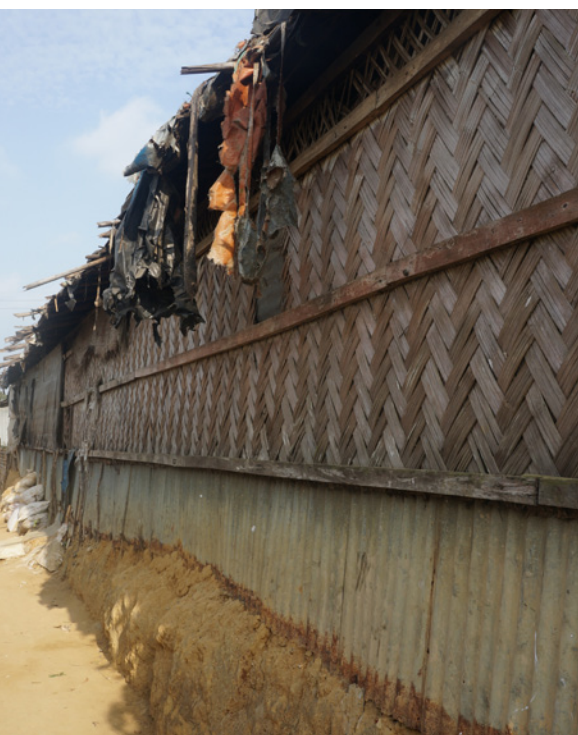
*Top:  
Drainage*

*Left:  
End-of-row shelter, resting on a mud platform  
CGI fence on gable wall , and CGI plinth + bamboo fence on  
sides.*

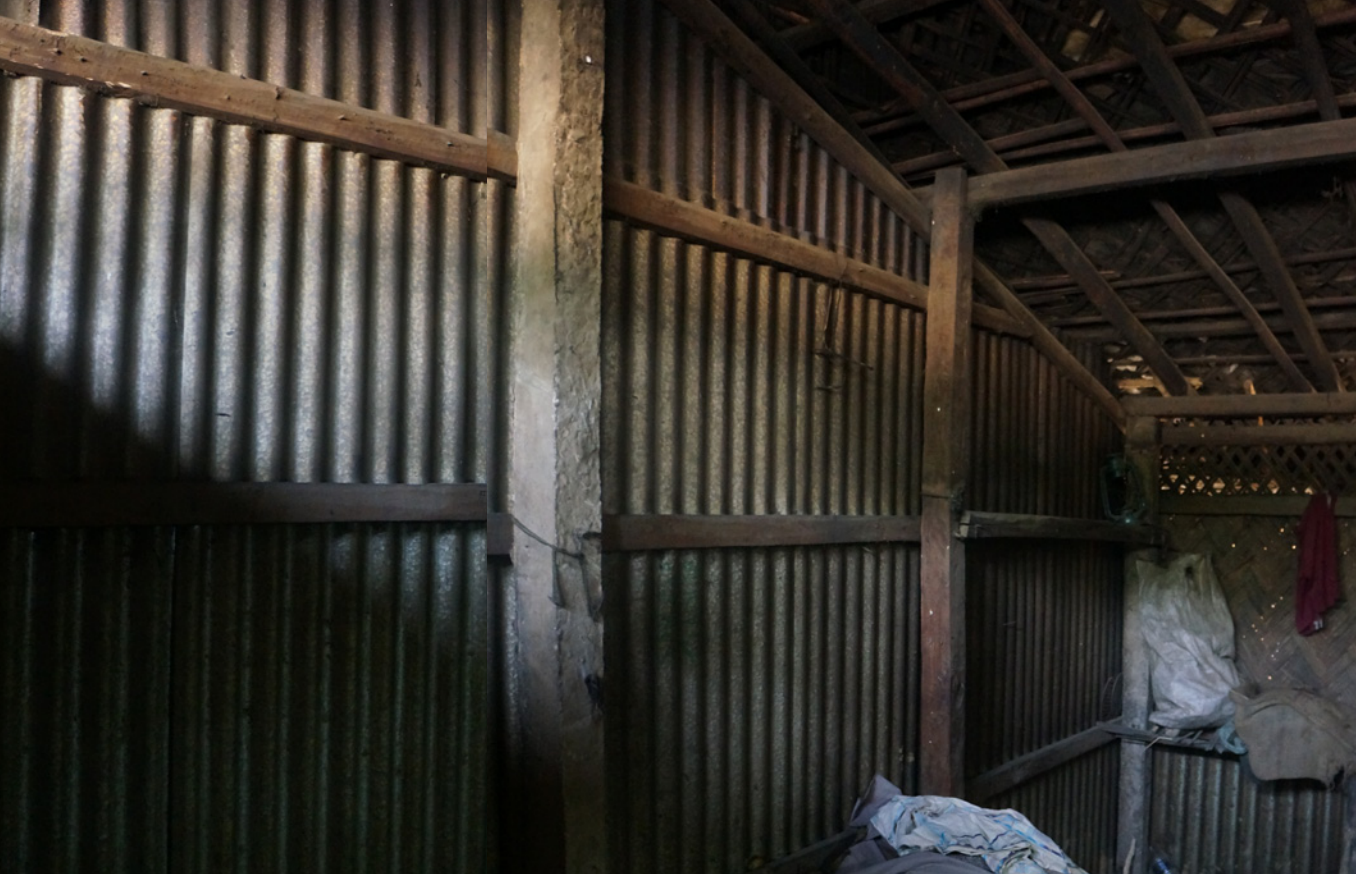
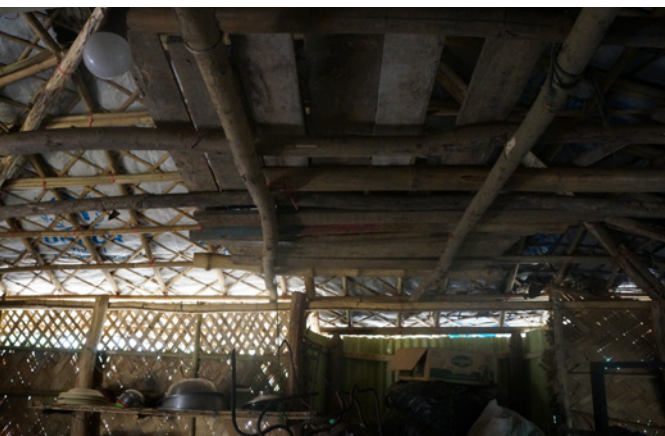
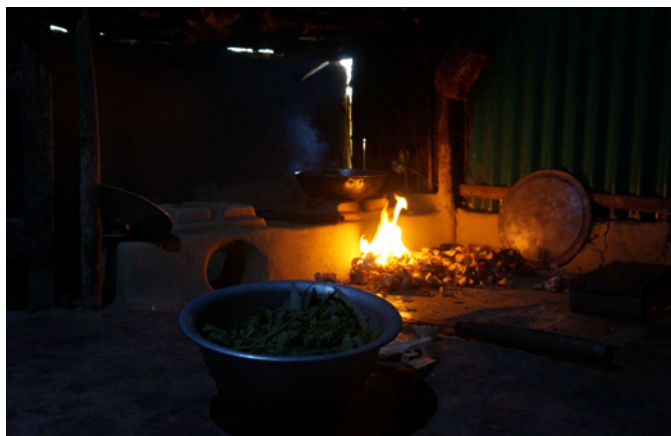
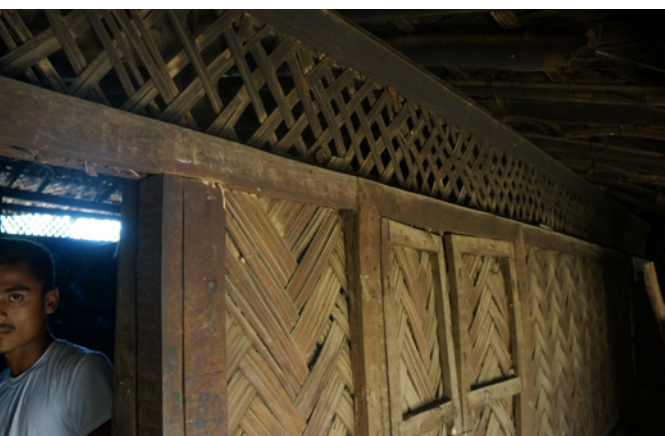
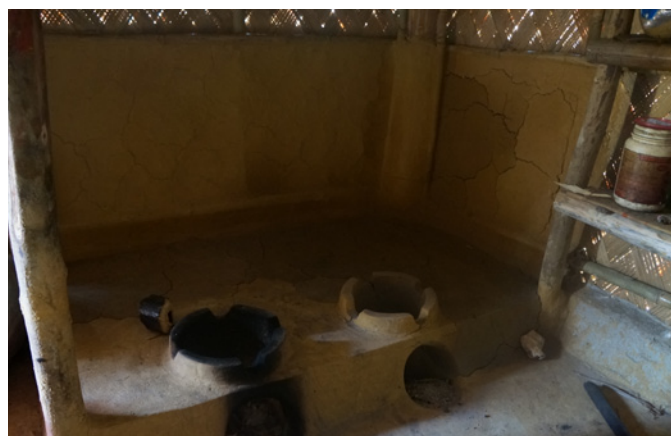
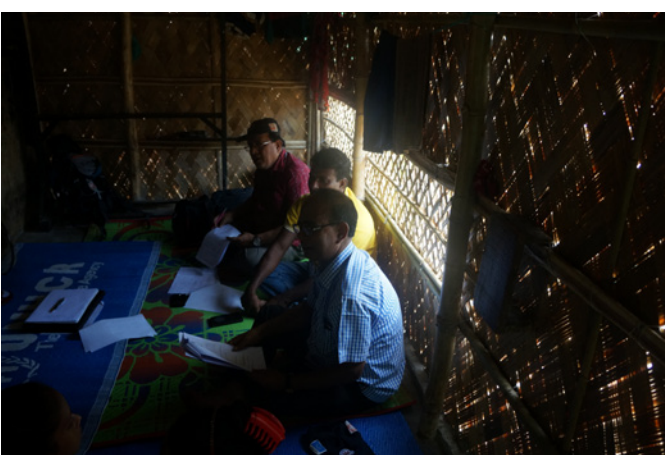
NB: CGI is quickly damaged at the interface with ground.

Bamboo mat is not waterproof: doubled inside with tarpaulin.

top :  
Main structure, RRC posts + wooden posts

Left:  
storage platform
